GRAMPAW PETTIBONE

Right and Wrong

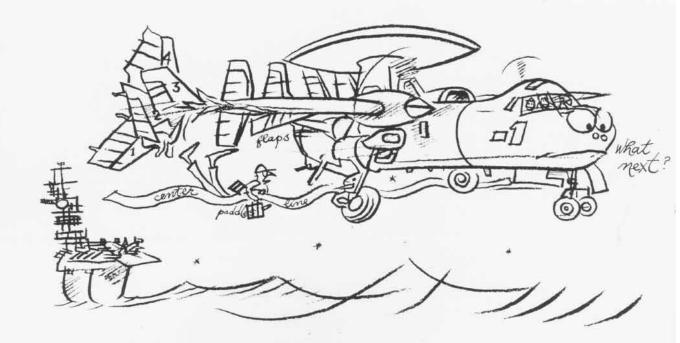
The aircraft went flat across all four cross-deck pendants in a steady right drift, touching down beyond the wires at a point six to eight feet forward of the number four cable. The touch-down point was six to eight feet right of centerline with the aircraft still drifting right. Maximum power was added for the bolter and the aircraft stopped drifting and continued down the angled deck, 15 feet right of centerline. Prior to becoming airborne, the E-2B's starboard wingtip made contact with the upper rudder sections of four A-7s parked clear of the foul line.

The pilot or crew was not aware of hitting the A-7s until notified by approach control. The crew then flew the aircraft to altitude where they performed a successful slow flight check. The only discrepancies noted by the crew were a missing wingtip cap and the fact that the flaps would not come up past the 1/3 position. The pilot reported a slightly mushy feeling in the controls. A FOD walkdown was performed on the flight deck to clear debris. The pilot flew another controlled approach, resulting in a hook

The investigation revealed that, on the first approach, the waving LSO stated the pilot overcontrolled a low start, drifted left in the middle but corrected nicely and, from an in-close position, was on centerline and on glide slope. The LSO further stated that the pilot decreased his rate of descent approaching the wires but was on centerline and appeared to have the wires made. The right drift during the final phase of the bolter is confirmed by the PLAT tape.

The pilot, copilot and air boss all stated that they observed the aircraft landing right of centerline four to eight feet. Evidence of the off-center landing was a line of tailhook trail marks clearly visible at 15 feet right of centerline. The impact was discovered by a taxi director who noticed debris. Damage to all the A-7s was limited. The E-2 damage was, fortunately,

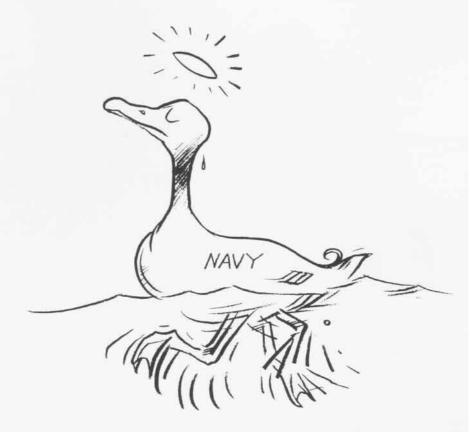
During this time, the pilot was moving the yoke back and forth and noted that there was no change in the aircraft attitude! He checked his rudder and aileron control which appeared to function normally. The aircraft was now approximately 50 miles from NAS Southcoast. The pilot attempted to control the nose attitude with trim which was successful. He declared an emergency, reversed course and requested a straight-in approach due to the loss of elevator control.

Through careful manipulation of power, judicious use of the trim tabs and some minor S-turns, the aircraft landed back at NAS Southcoast with no injury or damage to the aircraft. Inspection of the aircraft indicated a loose bellcrank assembly which was corrected and the aircraft made an uneventful return to Homeplate.
